DrillChem Explosion and Fire

Photo Log

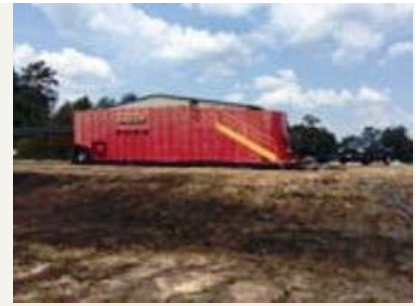
Description: Frac tank used for temporary storage of run-off pumped from secondary containment area.

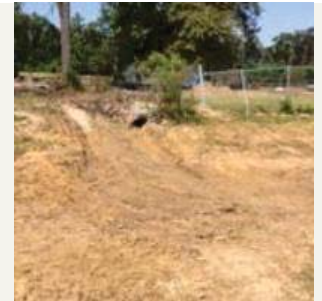
Description: View of culvert and area of excavated soil located in ROW.

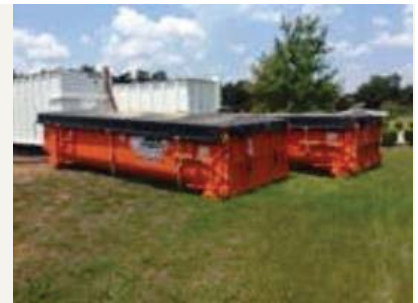
Description: Roll-off boxes containing soil excavated from ROW staged on-site.

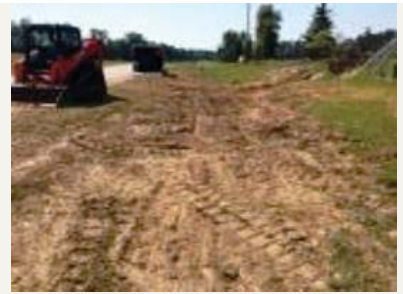
Description: Area of excavated soil located within the right of way.

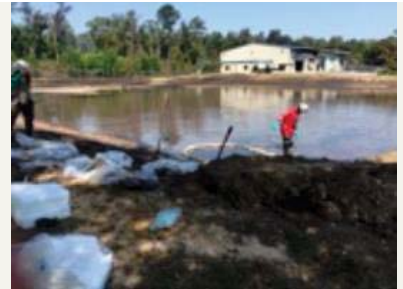
Description: Product and water removal from surface impoundment.

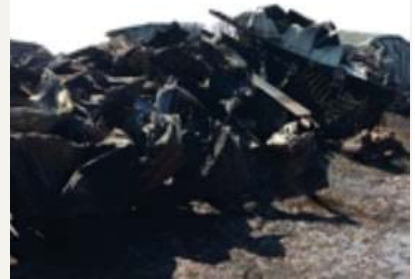
Description: Metal debris of the northern structure destroyed in the fire.

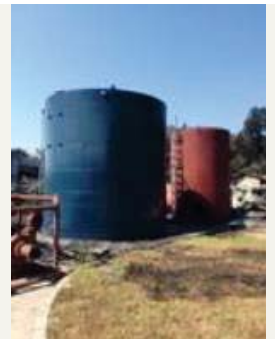
Description: 500 barrel and 210 barrel tanks. A third 210 barrel tank destroyed in the fire. No contents in the tanks reported by the RP.

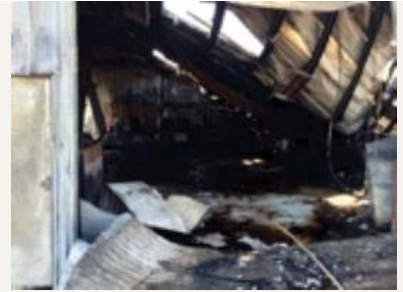
Description: View inside of southern most structure.

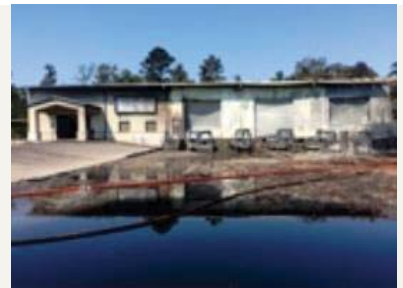
Description: View of facility looking west.

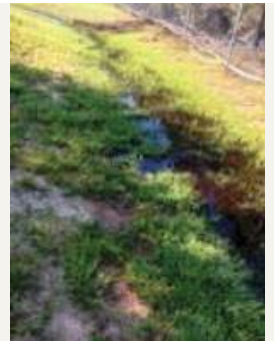
Drainage channel containing product located along the west side of the site.

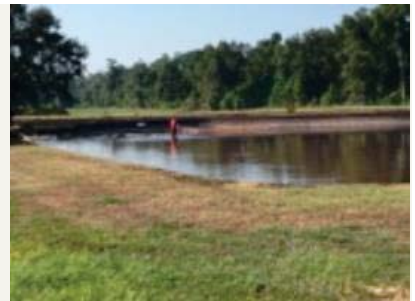
Description: Surface Impoundment located on the south side of the site.
